Facilities Assessment

Public Forum

February 28, 2015

The City of Dexter

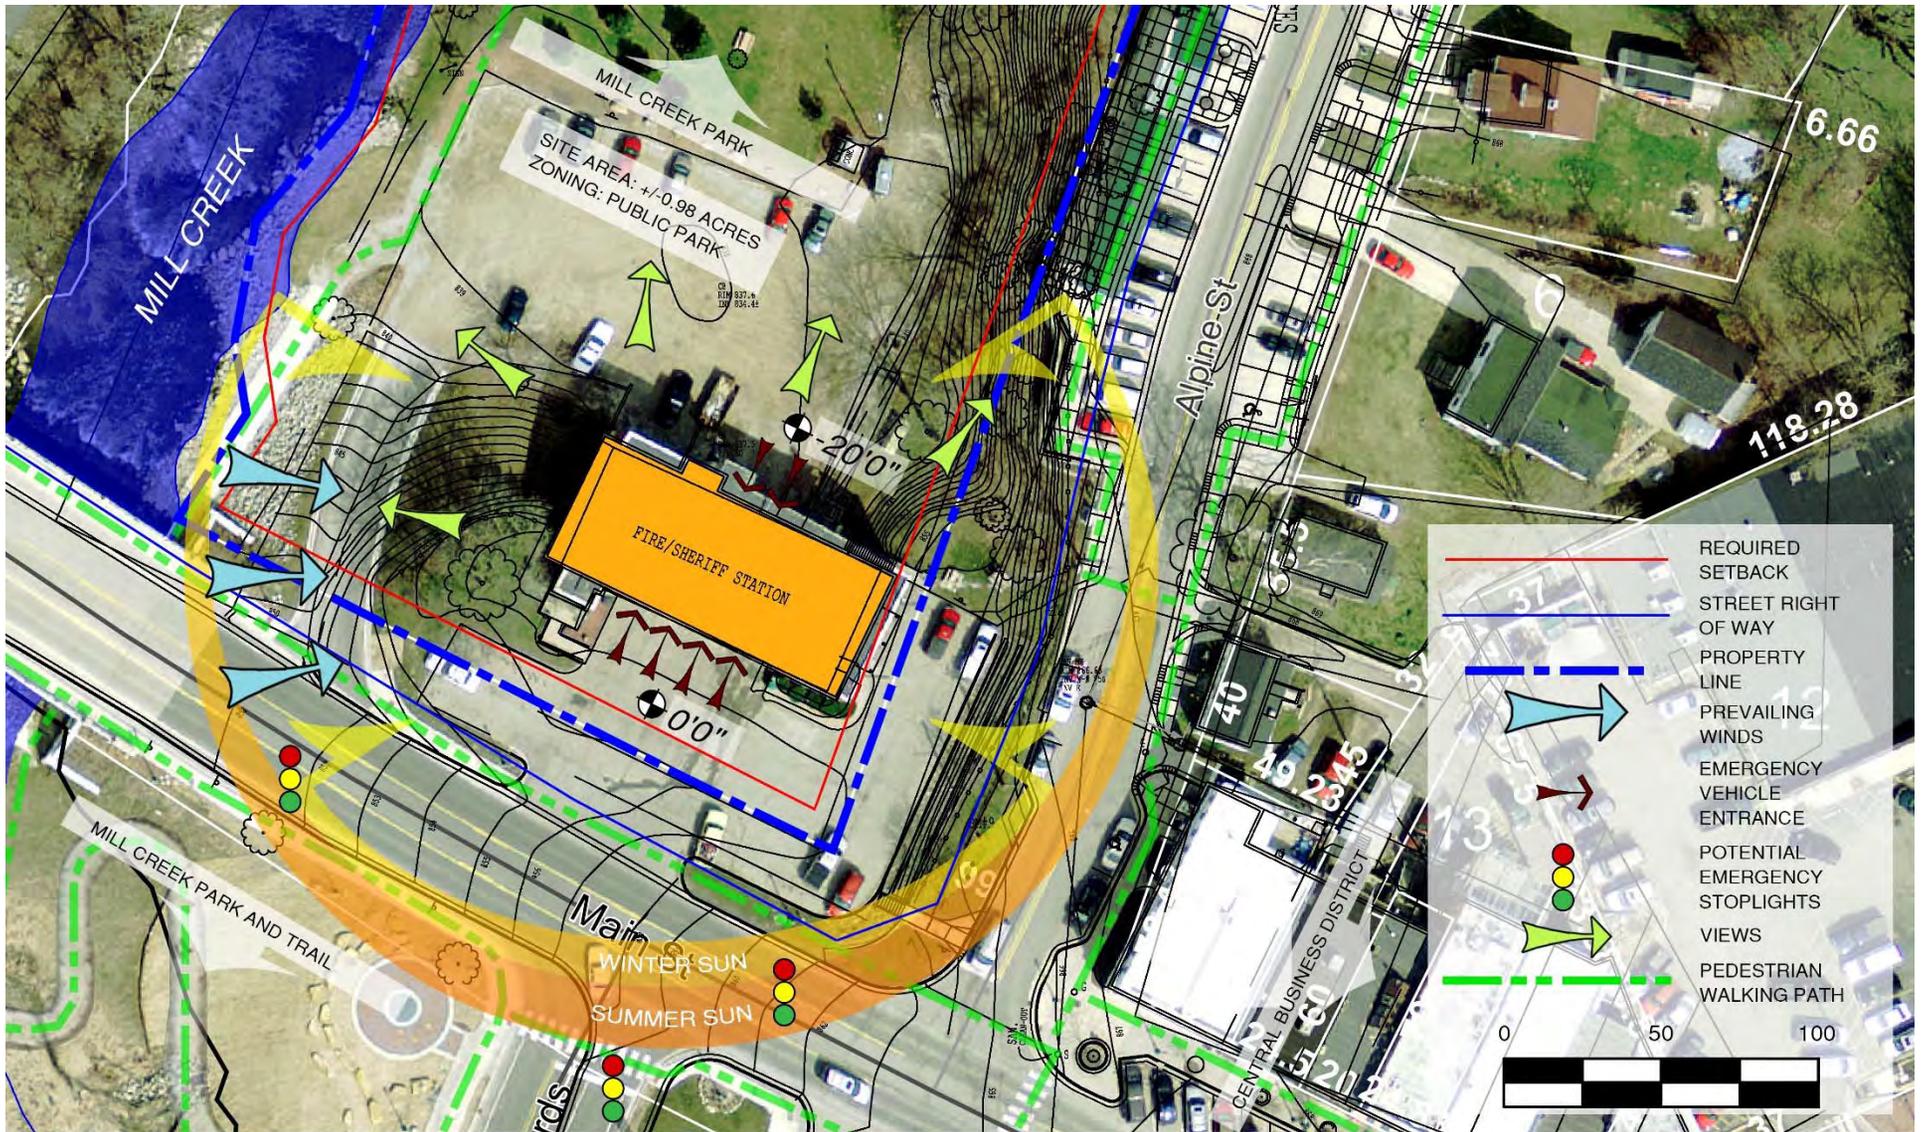
8140 Main Street – Existing Site Plan Analysis

- Approximately 55,000 S.F. and slopes approximately 38 feet from high to low.
- The main parking lot is in poor but serviceable condition.
- The rear parking area is gravel in fair condition and accessed by a newer asphalt drive in excellent condition.
- The drive is steep and offers no dedicated pedestrian walk to the lot below.
- The overall traffic pattern presents congested egress for fire vehicles with no control of the adjacent traffic signal.

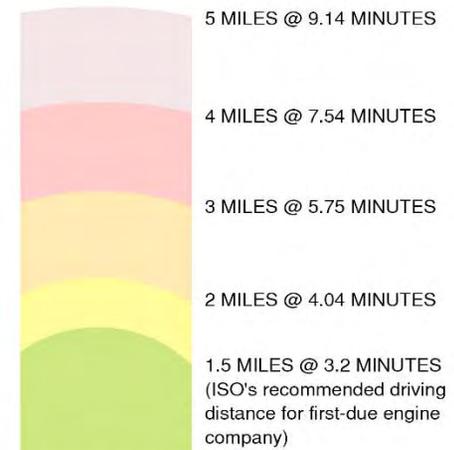
RESPONSE TIME CONSIDERATIONS:

Response time considerations provided by ISO, a leading source of information about risk supported by many federal, state and logical agencies.

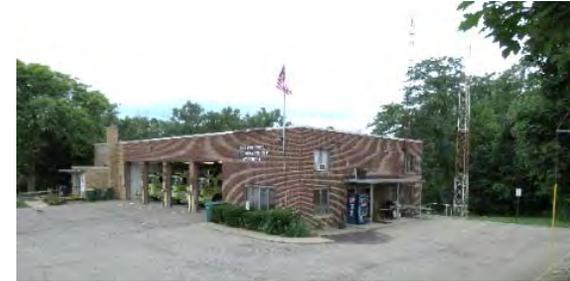
Approximate Building size is 9420 SF - Overall, the building is in fair to good condition

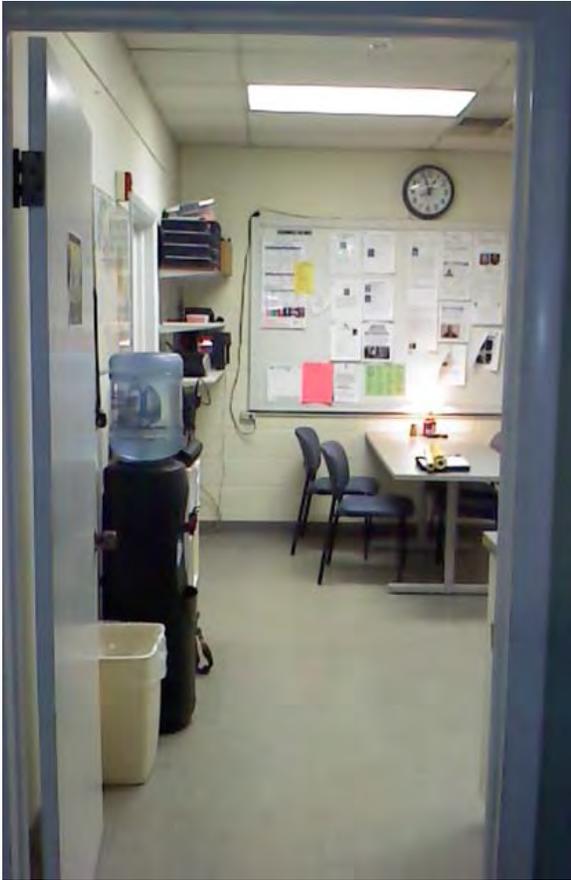
8140 Building Conditions - Sheriff

- Sheriff Substation area is just adequate for the current staffing and will not allow for expansion or added function.
- The current open office area offers only marginal privacy for law enforcement operations and limited security.
- The public has visual access to potentially sensitive information causing interruption.
- Toilet facilities are inadequate and remote from the locker area with no shower facility available.
- There is no separate female locker area available.
- Private interview area available is the sheriff's private office.
- Secure storage for weapons is a weapons locker housed in the locker room area.
- Break room facilities and squad room, and secondary egress path are all the same room.
- There is no adequate storage area for files, evidence, office and maintenance supplies.
- Communications equipment space, including the data server is housed in a small closet area.

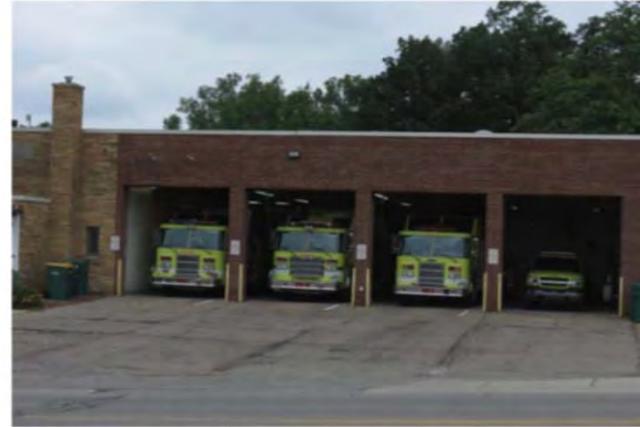
001

Village of Dexter Building Assessment Dexter Area Fire Department												
ID	Issues / Description (s)	Recommendation (s)	Accessibility	Security/Safety	Energy/Efficiency	Compliance/Code	Operational Efficiency	Program/Function Support	Asset Preservation	Appearance	Photo	Priority (1,2,3)
\$ 1.01	Upper level asphalt paving is in fair to poor condition. Asphalt paving show elongator cracking and longitudinal splits. The lot appears to be well drained. Subbase failures occurring.	Replace asphalt paving with necessary stone base undercutting.		X						X	X	002, 003, 005,
\$ 1.02	paved site circulation and upper parking area accommodates both sheriff, public, fire vehicle, fire department parking and is inadequate. Deployment of the fire vehicles could be in conflict with onsite circulation.	Reconfigure parking lot and circulation patterns.	X	X			X					002, 003
\$ 1.03	Traffic patterns at the approach is not controlled by a fire department controlled traffic signal. The road is often congested during peak travel times making fire vehicle deployment difficult at times. Adding a signal would likely involve multiple signals in order to clear traffic through the adjacent street.	Install traffic signal control systems and signal locations to aid in clearing surface traffic.		X			X					001, refer to overall site aerial photo

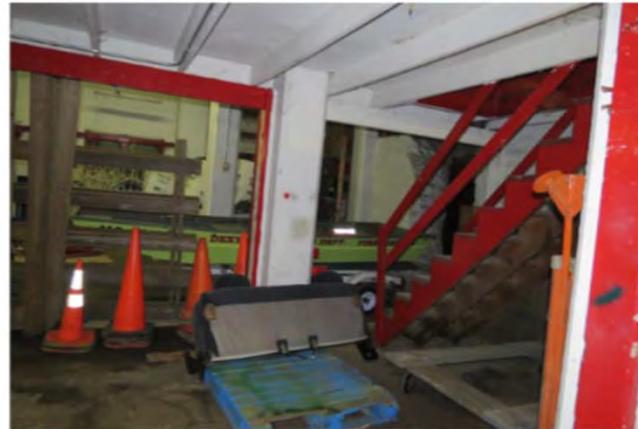
110

12.04	Lower level mezzanine has one egress point and requires two.	Add second egress stair from west mezzanine.									110,	
IC Corridor Protection

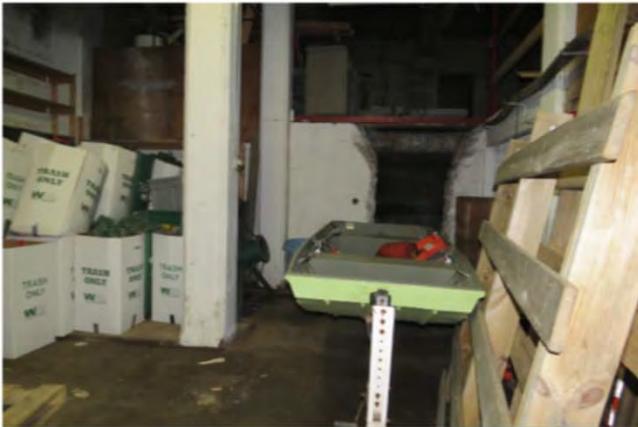
112

11.09	opening to power generation areas exists without door and adequate lighting in area.	Add door, ventilation, and lighting in areas.									112,	
IC Egress Routes
